**CWA COMPLIANCE EVALUATION INSPECTION REPORT
U.S. ENVIRONMENTAL PROTECTION AGENCY, REGION 5**

Purpose: Compliance Evaluation Inspection

Facility: Calf Land, LLC.

Date of Inspection: October 31, 2013

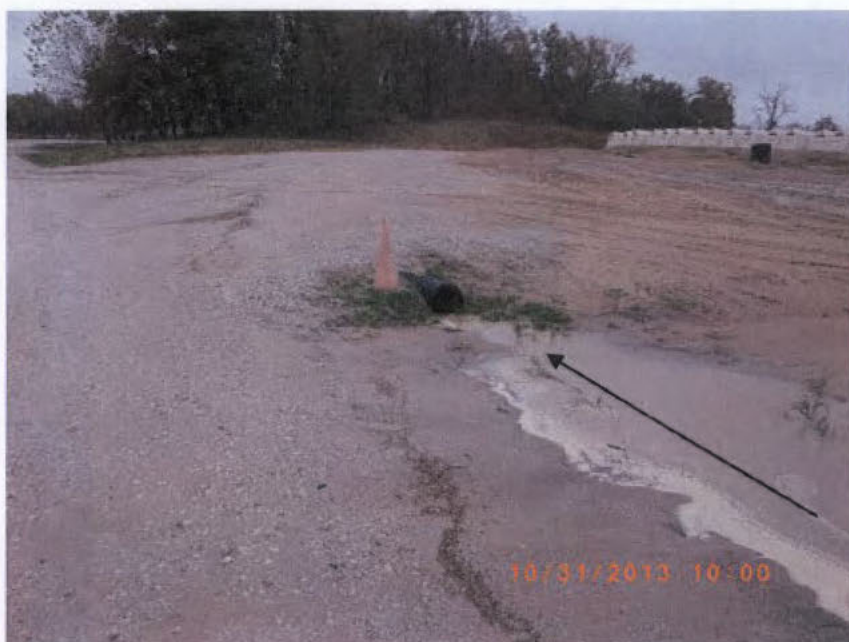
6: IMGP0528

The walkthrough of the Facility began at approximately 9:52 AM at the north end of the facility. In the area south of the Feed Storage Barn, the inspectors observed surface runoff flowing east into a culvert under the access road (photos 6 and 7). The inspectors walked southwest around the office building and south along the west side of the Calf Hutch Area (CHA). The inspectors observed surface runoff from the CHA flowing south along the west side of CHA, along a flow path through the wooded area at the southwest corner of Facility, and into the field south of the Facility (photos 11-22). The inspectors walked west along the wooded area/field edge and observed standing water along the south edge of the wooded area (photo 23). The inspectors then walked north and observed two pipes, beneath a berm, conveying surface runoff south from the grassed swale located centrally in the Facility which divides the west side (the CHA) from the east side (Pen Area) (photos 24 and 25).

Description: Water flowing into drain culvert. Arrow indicates direction of flow.

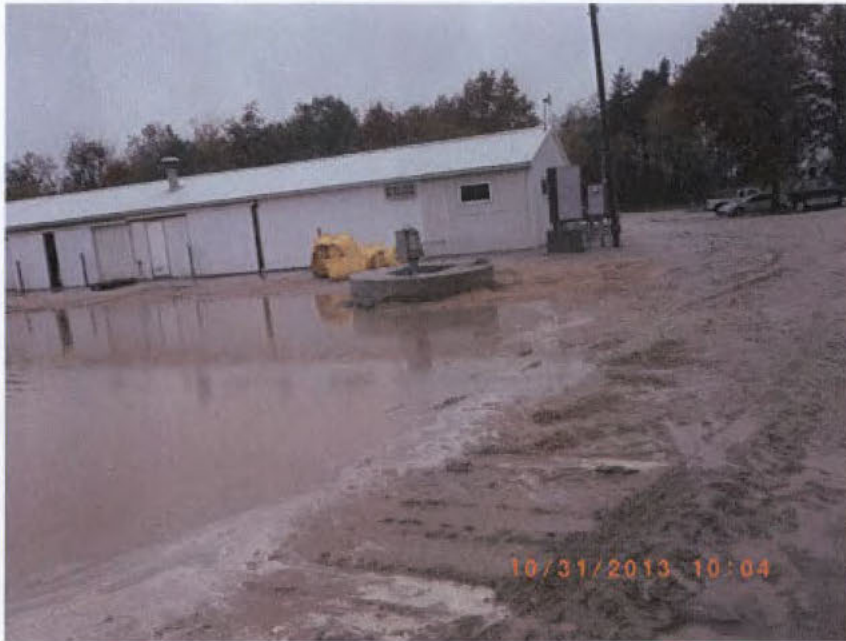
8: IMGP0530

Description: Lift station for contaminated storm water. Pumps to manure storage pond.

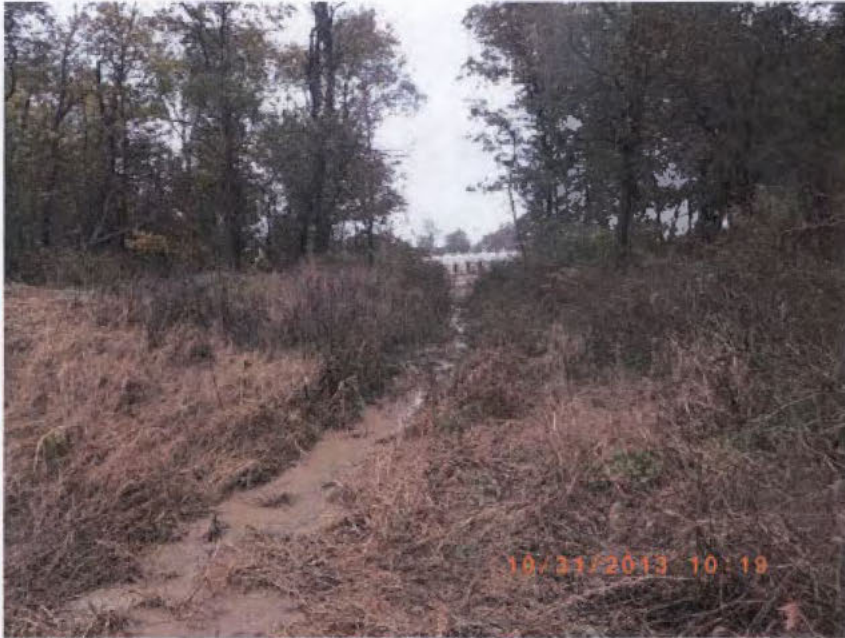
18: IMGP0540

Description: Looking northeast along ditch conveying runoff from calf hutch area. Flow is to the southeast.

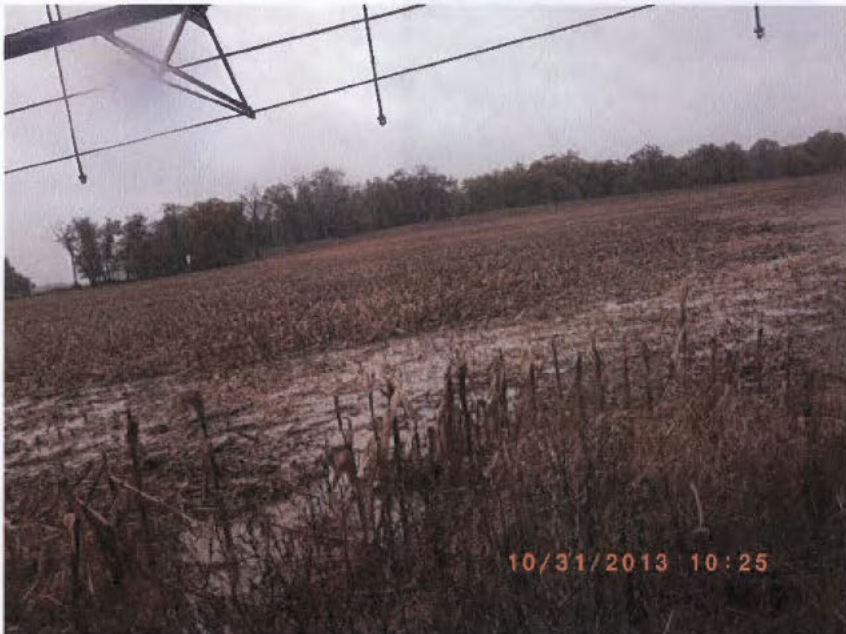
21: IMGP0543

Description: Looking south in field south of facility at end of ditch conveying runoff from calf hutch area.

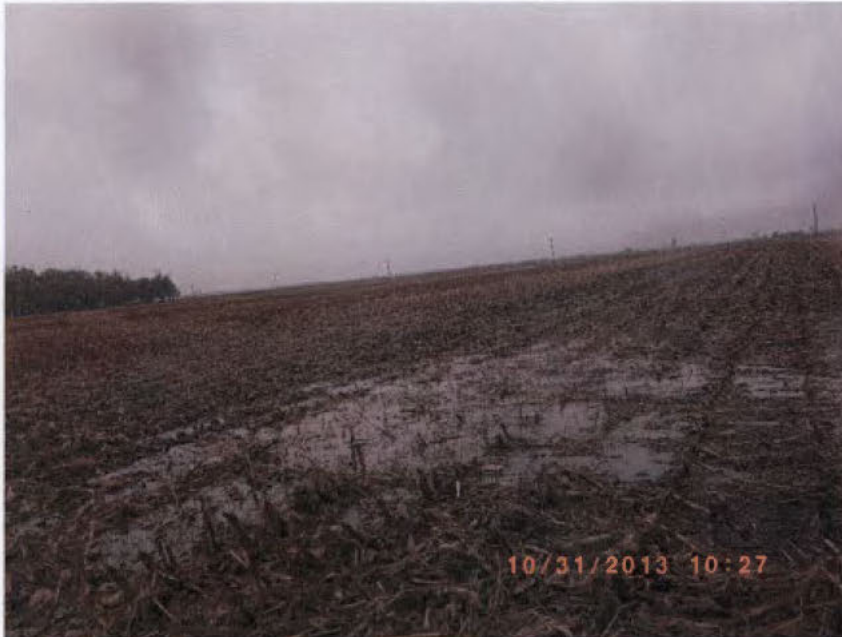
22: IMGP0544

At the time of the inspection, surface runoff from the Calf Land site was observed to be flowing to an agricultural field south of the facility and was not observed flowing out of the field. Based on the flow of waterways mapped on the National Hydrography Dataset by the United States Geological Survey, the Surface runoff from the Calf Land site can flow through drainage ways to the Iroquois River that is approximately 15 miles from the facility.

Description: Runoff from facility pooling in field south of facility.

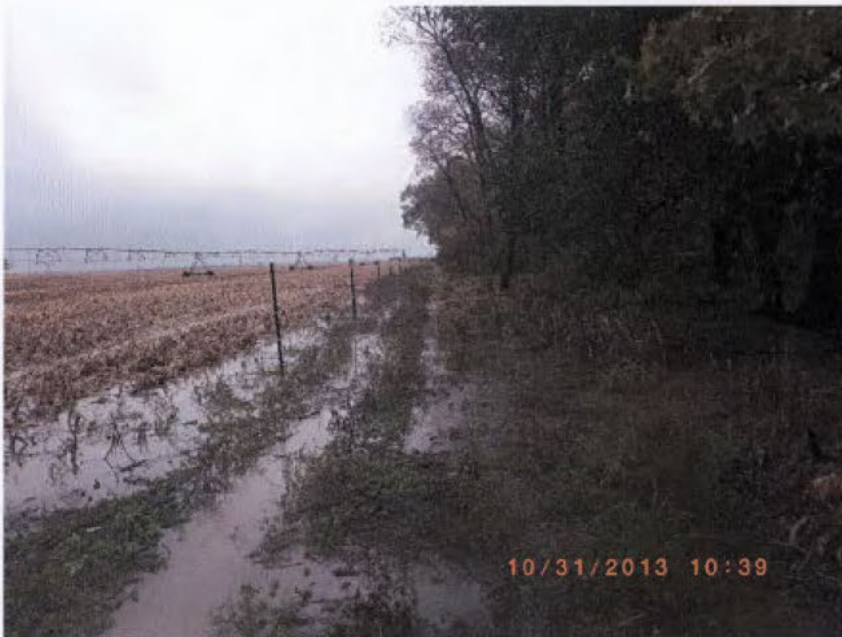
23: IMGP0545

Description: Looking west along tree line south of facility. Stormwater from facility is flowing into this area from pipes under access road located out of photo on the bottom right.

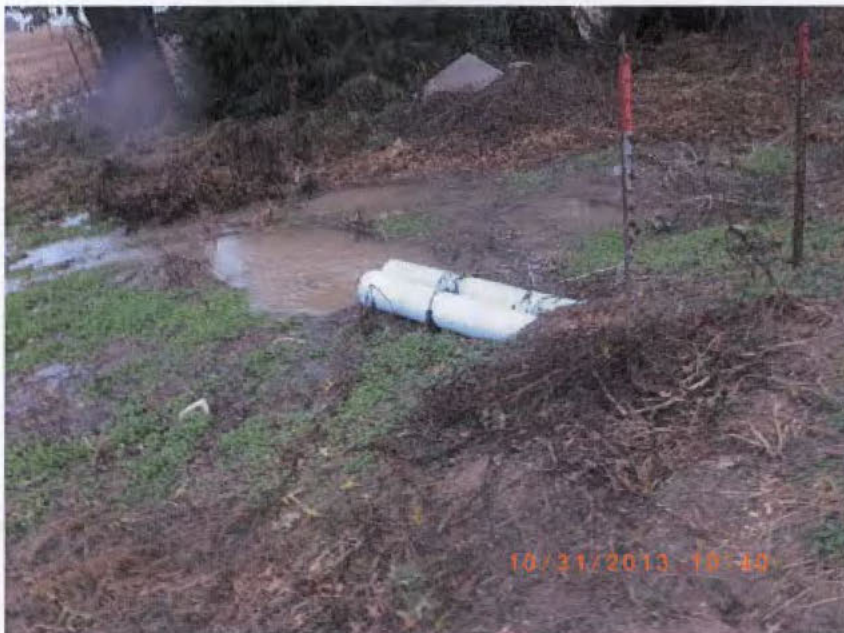
25: IMGP0547

Description: Outfall side of pipes conveying process waste water.

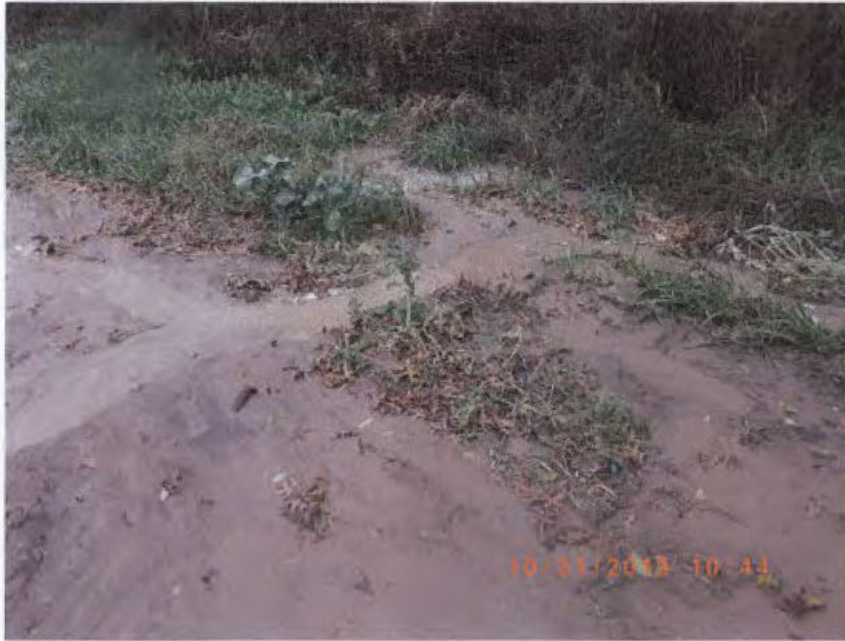
28: IMGP0550

The inspectors walked north along the west side of the grassed swale and observed surface water runoff from the CHA flowing into the grassed swale area (photos 26-32). The inspectors also observed a white concrete riser with a white pipe protruding vertically from the middle of it (photos 33 and 34). The Facility Manager stated that she did not know what this was.

Description: Surface runoff from calf hutch area flowing into grassed swale between calf hutch area and open lots.

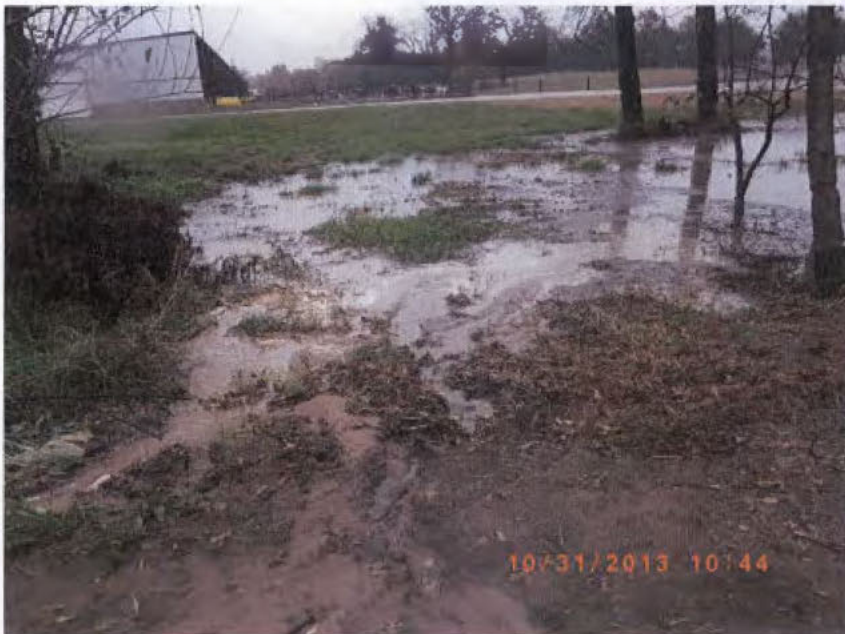
29: IMGP0551

Description: Surface runoff from the calf hutch area flowing to the grass swale between the calf hutch area and the open lots.

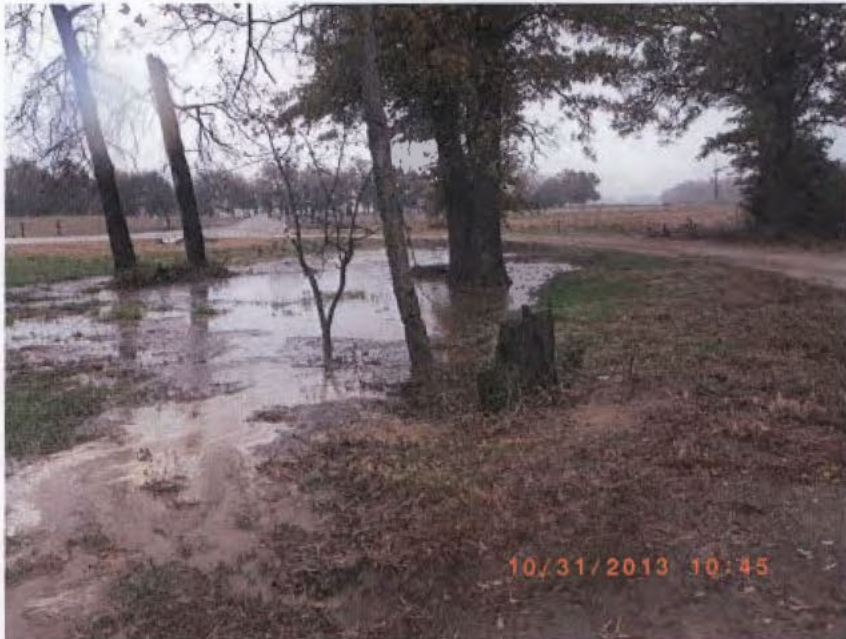
30: IMGP0552

Description: Surface runoff flowing south in grassed swale to the pipes under access road shown in photos 24 and 25.

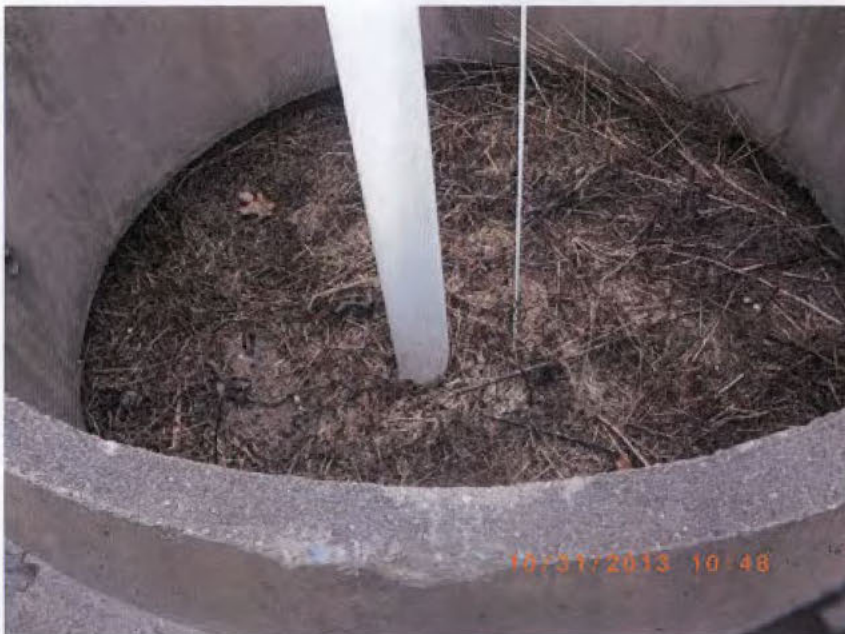
33: IMGP0555

Description: Concrete riser with verticle white pipe. Manager did not know what this was.

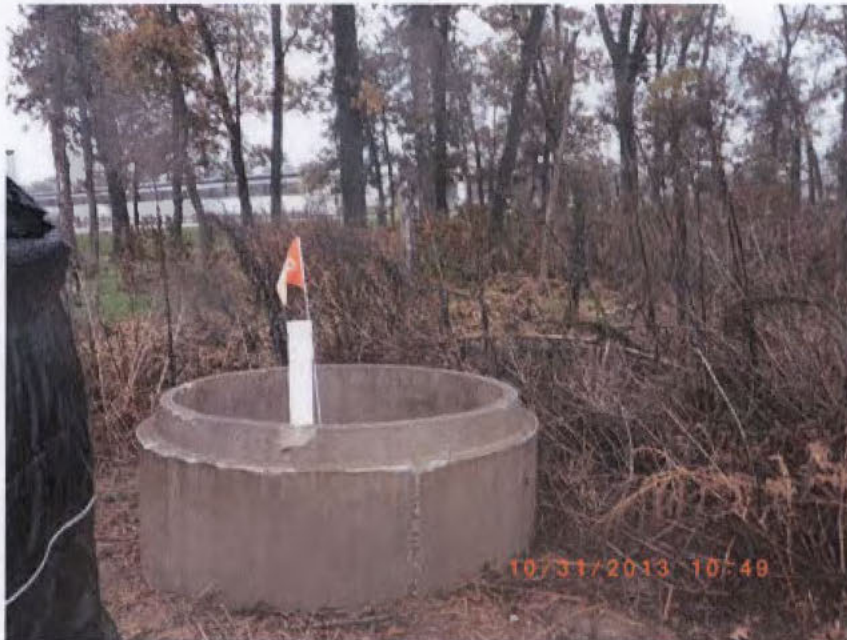
34: IMGP0556

Description: Concrete riser with verticle white pipe. Manager did not know what this was.

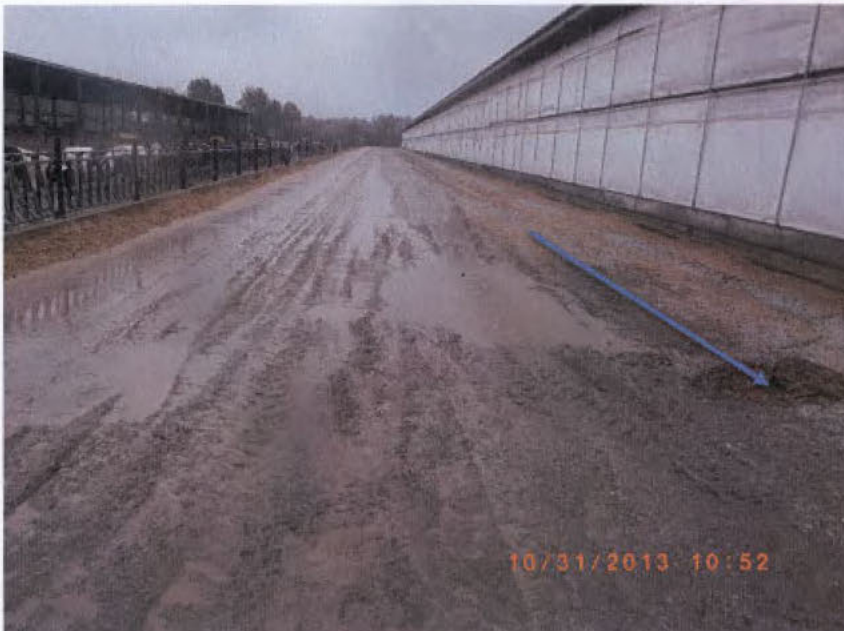
37: IMGP0559

The inspectors walked north on the east side of the CHA and observed the ends of two pipes arranged at 45 degrees from one another in the grassed swale area west of pen 5 (photos 38 and 39). It appeared that the pipe laying east to west was conveying flow from a manhole surface drain located in the access road between pen 4 and pen 5 (photo 37).

At the conclusion of the inspection, I summarized my findings and observations to Ex. 6
Ex. 6 (Personal Privacy) I noted that I was concerned that runoff from the Calf Hutch Area and the manholes on the roads between the pens was not contained and was allowed to flow to the field to the south and might have the potential to flow to a surface water in a high enough precipitation event.

Description: Looking east along the back of pen 4 (right) and pen 5 (left). Note manhole in access road.

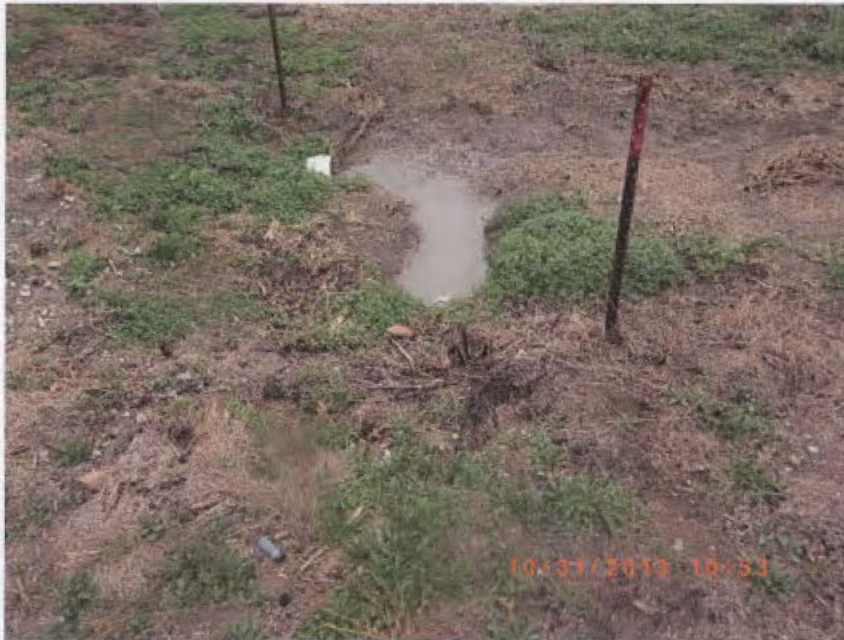
38: IMGP0560

Description: Gree pipe (bottom) coming from the east and flowing into white pipe (top) to the south on west side of central access road.

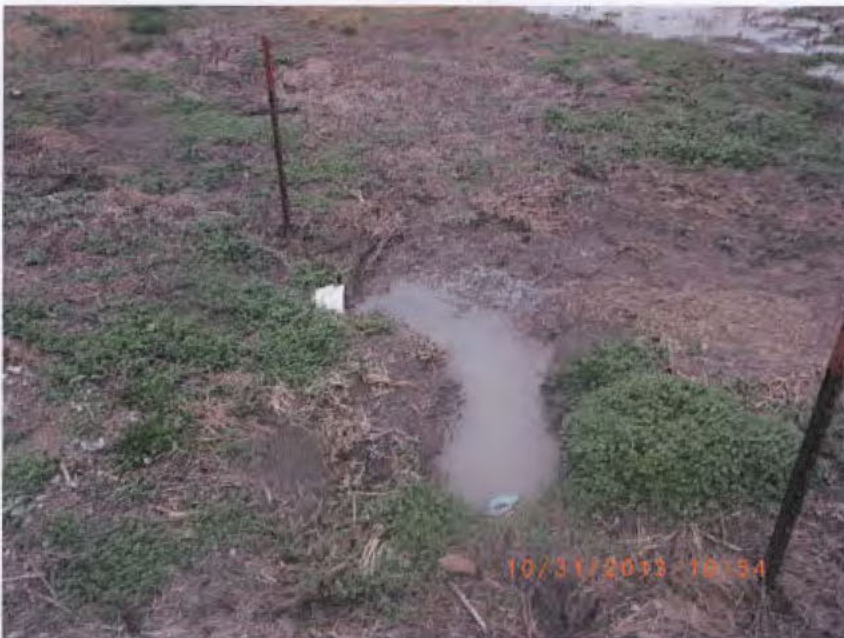
39: IMGP0561

Description: Gree pipe (bottom) coming from the east and flowing into white pipe (top) to the south on west side of central access road.

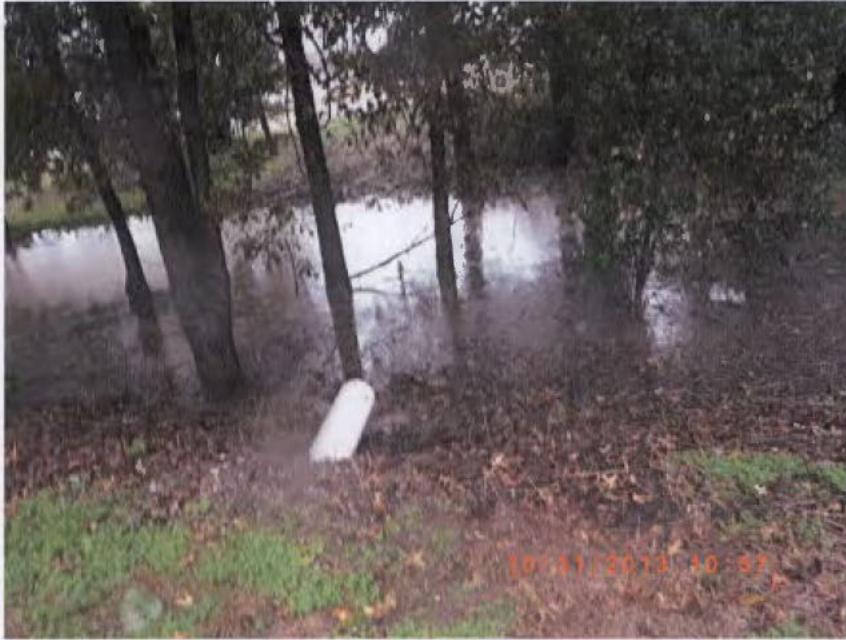
42: IMGP0564

The inspectors walked north and observed a white pipe protruding into the grassed swale from the west just west of pen 5 (photos 42 and 43). The inspectors continued north on the central access road and observed a pipe in the grassed swale under an east west access road conveying flow to the south (photos 45 and 46). The inspectors continued walking to the north end of the facility and observed surface water from the north end of the facility flowing into a pipe (photos 47 and 48). The inspectors also observed a concrete riser adjacent to the feed storage barn which had a small white pipe which appeared filled (photos 50 and 51).

Description: Pipe under across road across grassed swale in center of facility.

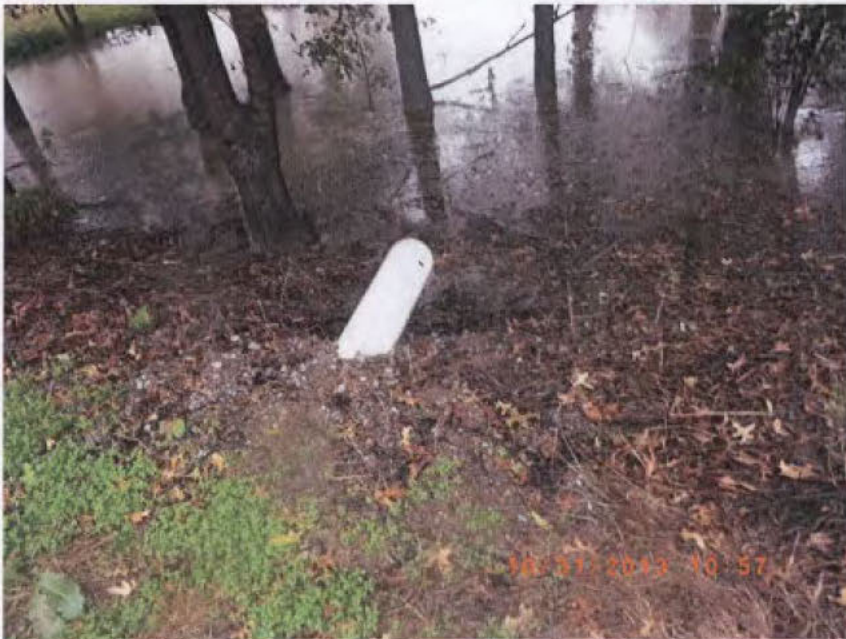
43: IMGP0565

Description: Same as photo 42

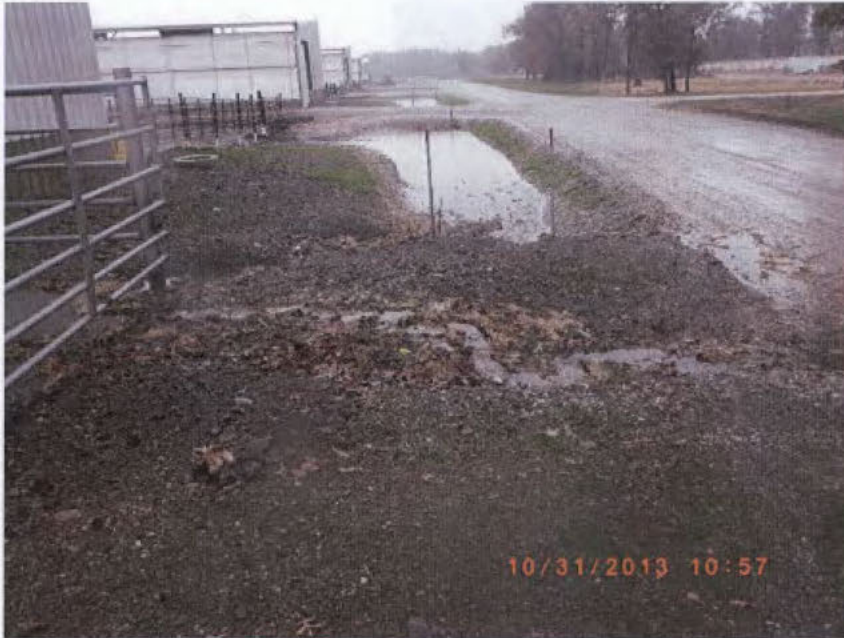
44: IMGP0566

Description: Ditch which runs north south along western edge pen area. This ditch collects and transports runoff from the lots to the manure pond to the south.

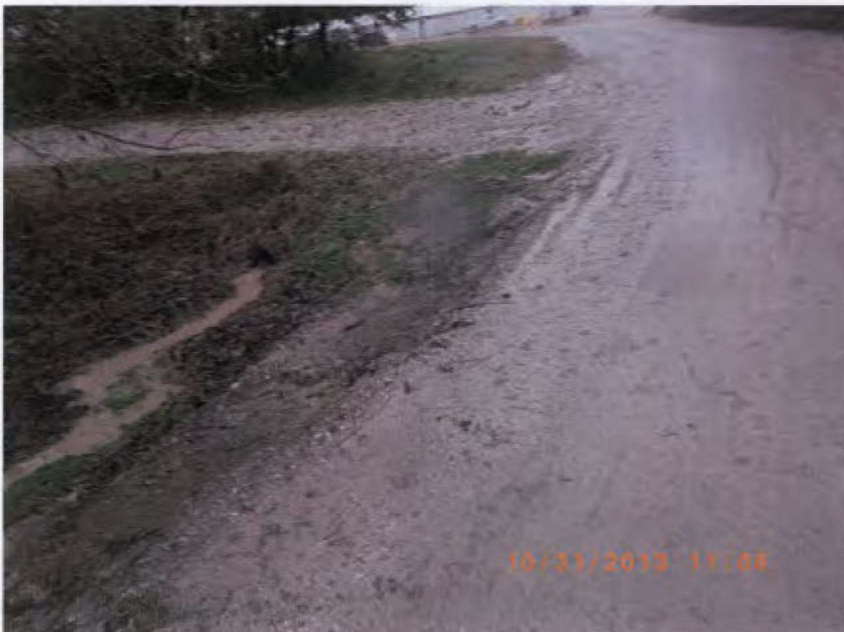
45: IMGP0567

Description: Surface runoff flowing to the south in grassed swale between calf hutch area and pen area.

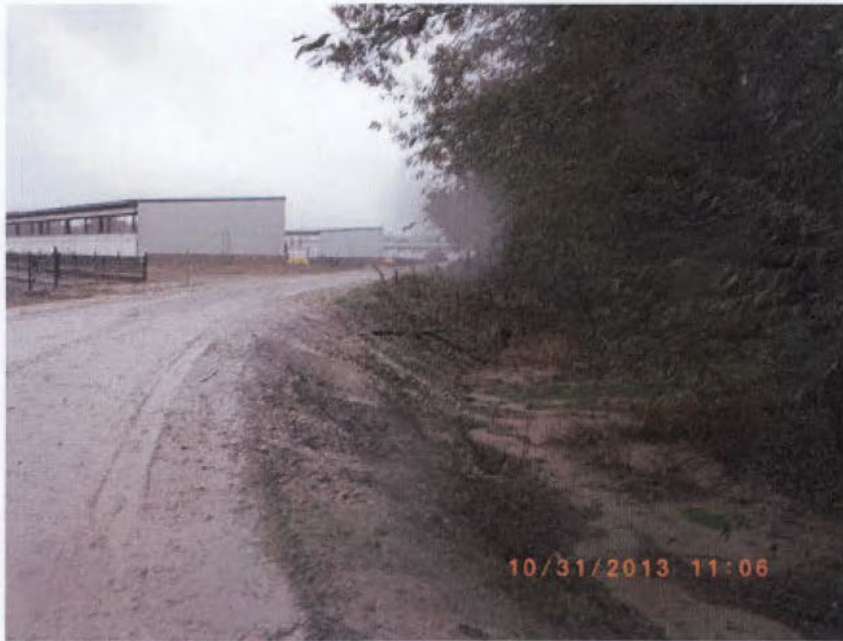
46: IMGP0568

Description: View along central access road. Grassed swale conveying surface runoff to the right.

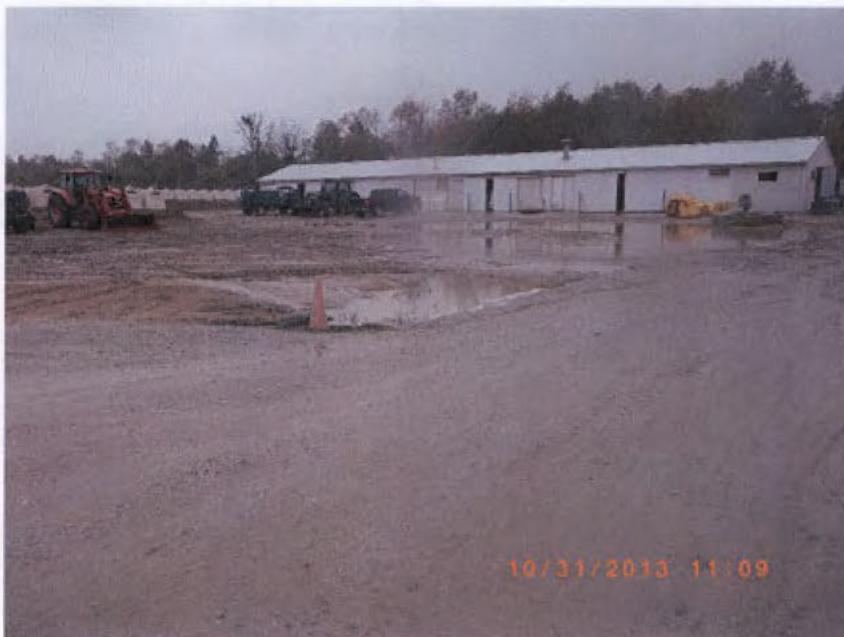
47: IMGP0569

Description: Surface water flowing to manhole (orange cone) which conveys surface runoff to grassed swale along central access road. Office building in distance.

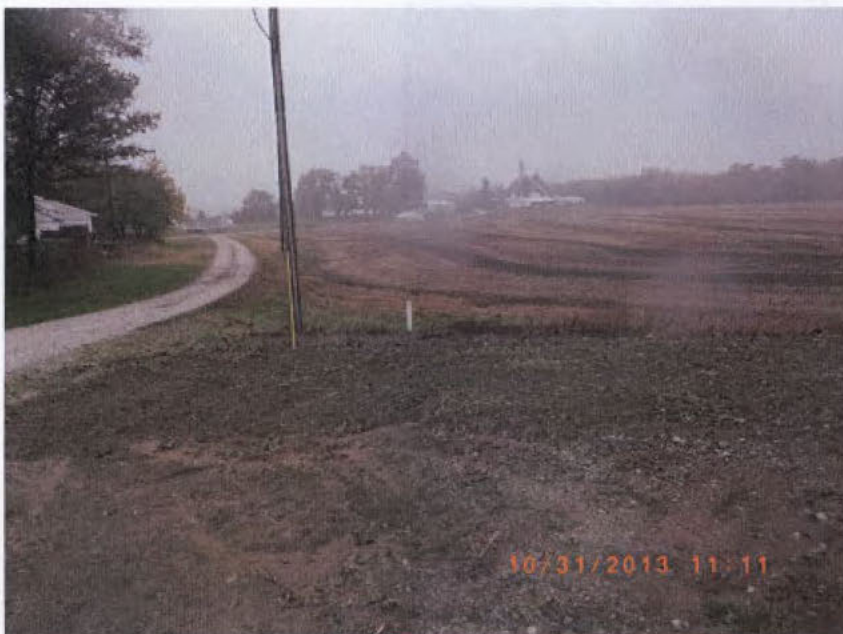
49: IMGP0571

Description: Driveway to the northwest.

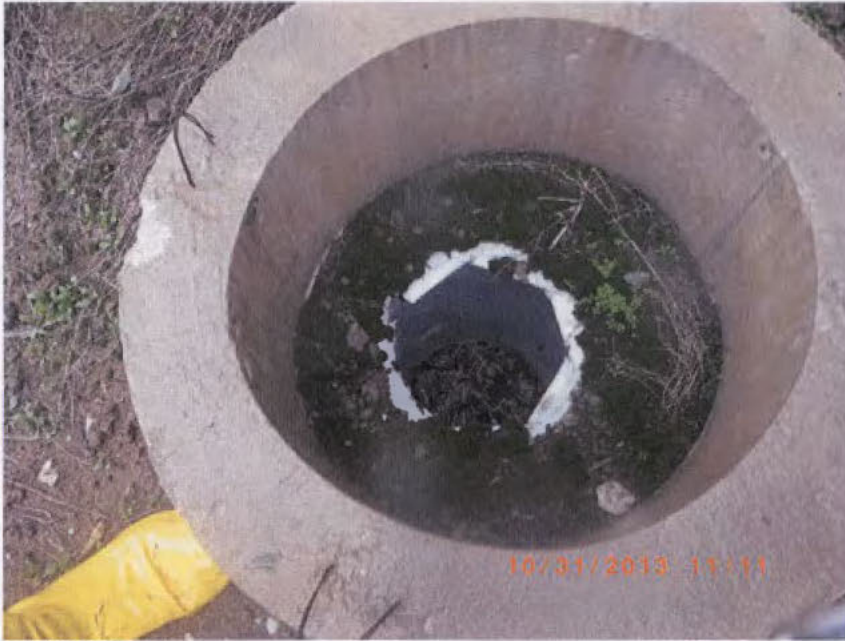
50: IMGP0572

Description: Concrete riser with pipe located next to feed storage barn.

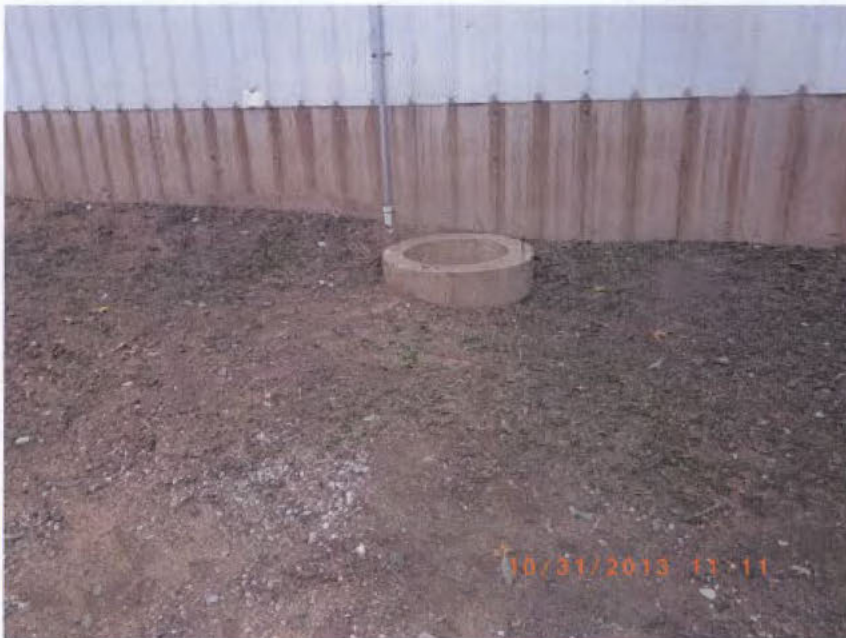
51: IMGP0573

Description: Concrete riser with pipe located next to feed storage barn.

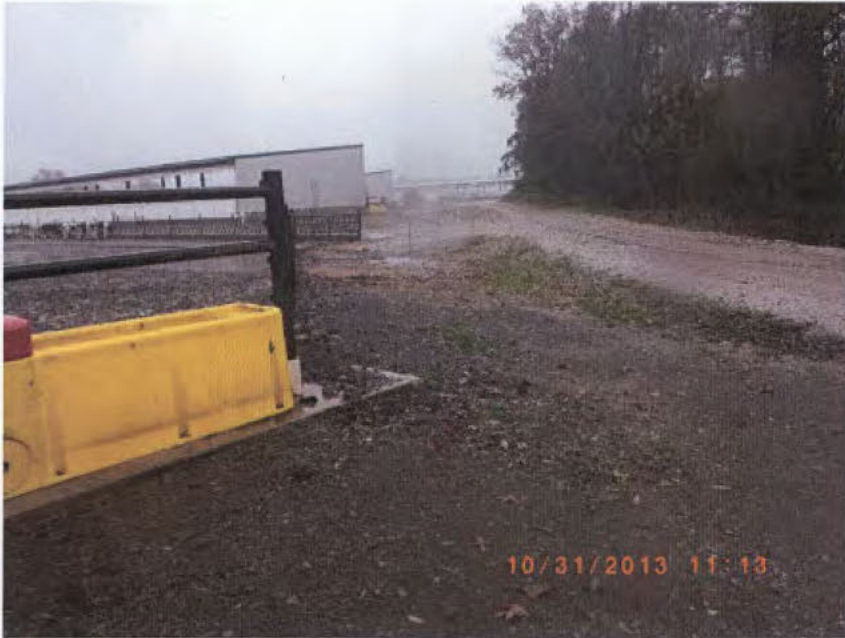
52: IMGP0574

Description: Looking southeast along west end of pens.

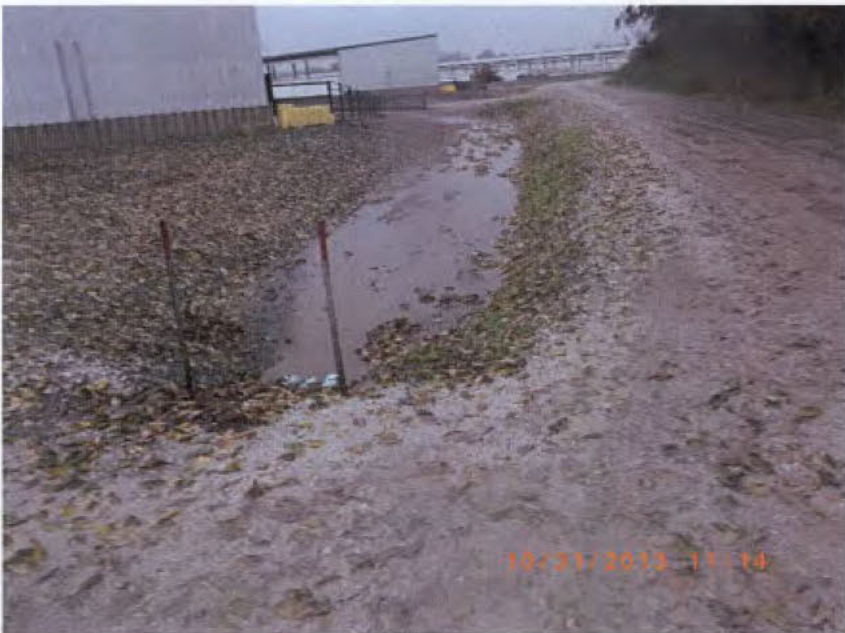
53: IMGP0575

Description: Ditch on east side of central access road which collects and conveys surface runoff from pens.

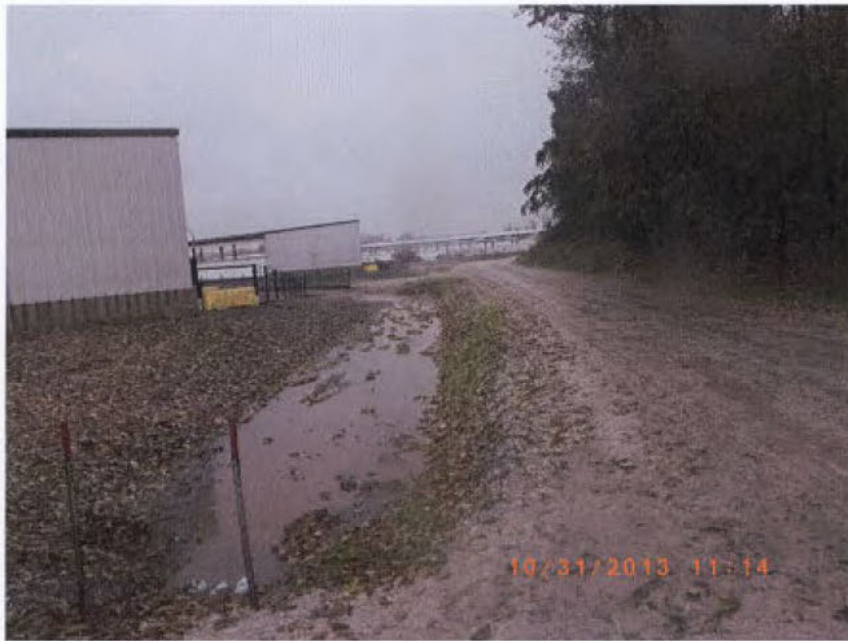
54: IMGP0576

Description: Same as photo 53

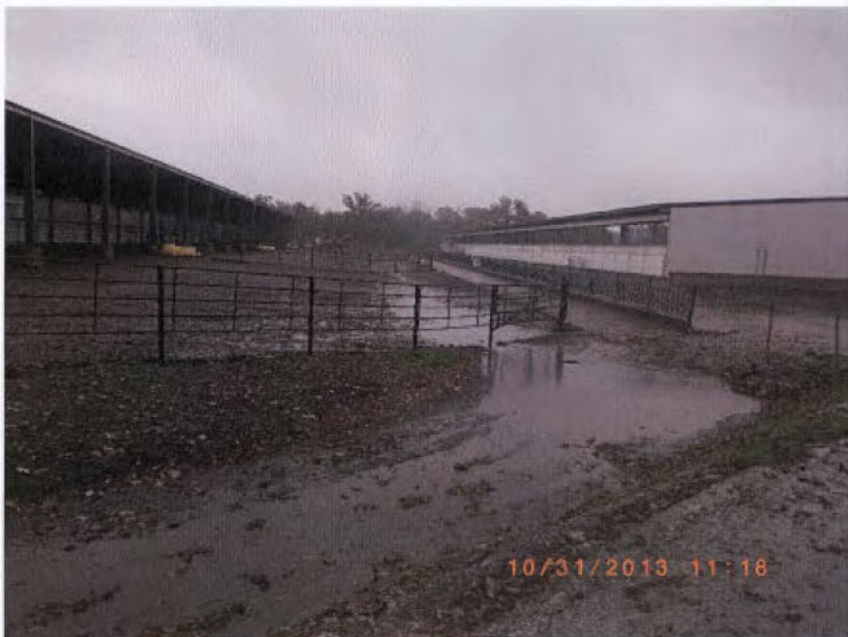
55: IMGP0577

Description: Surface runoff from Pen 7 (left) flowing to ditch on east side of central access road.

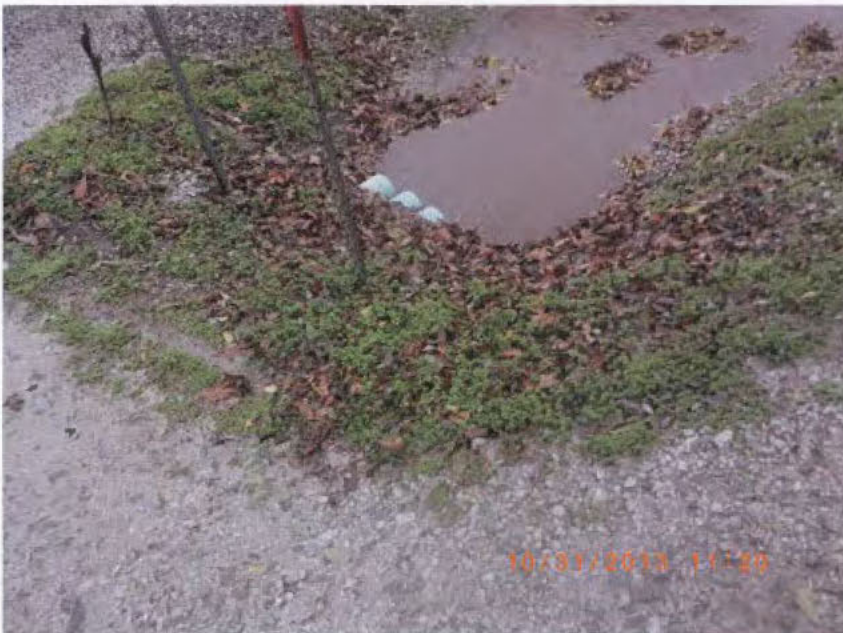
57: IMGP0579

Description: South end of pipes under road between Pen 7 and Pen 6.

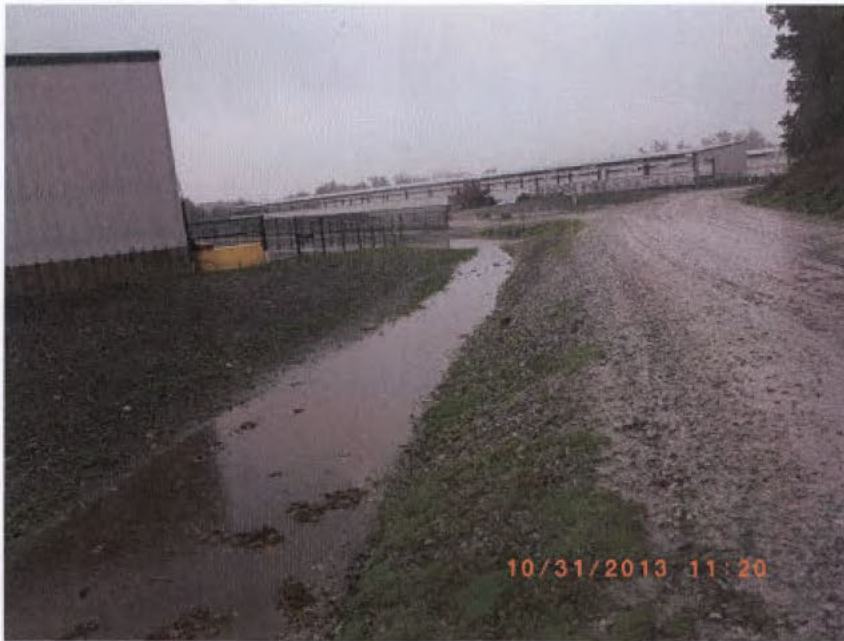
58: IMGP0580

Description: Surface runoff from pen area flowing south in ditch on east side of central access road.

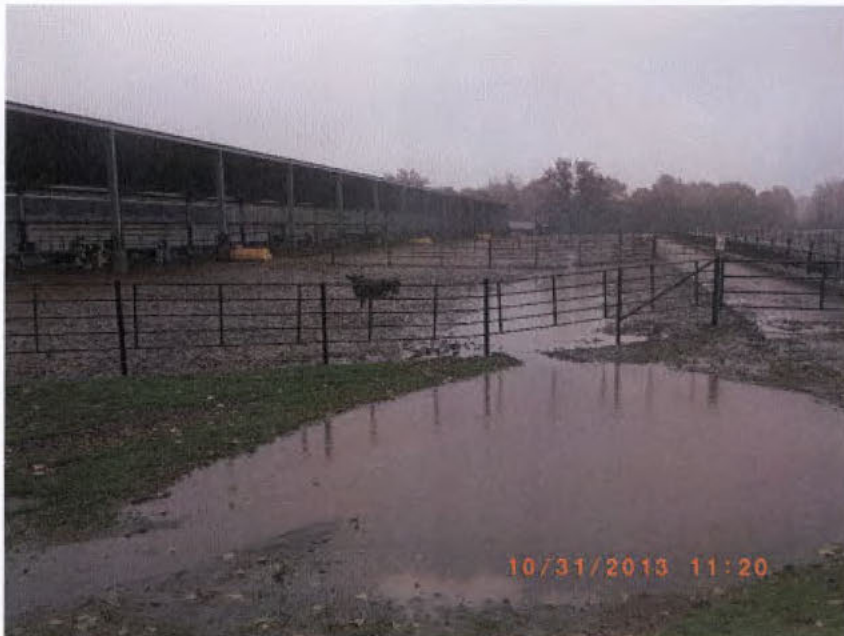
59: IMGP0581

Description: Runoff from Pen 6 flowing to ditch on east side of central access road.

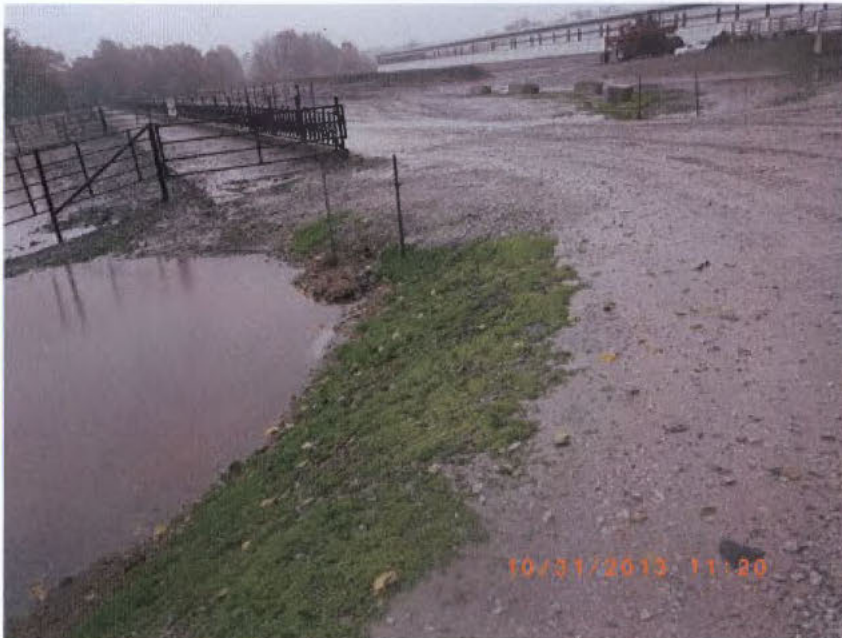
60: IMGP0582

Description: Ditch flowing into pipes under road between Pen 6 and compost area.

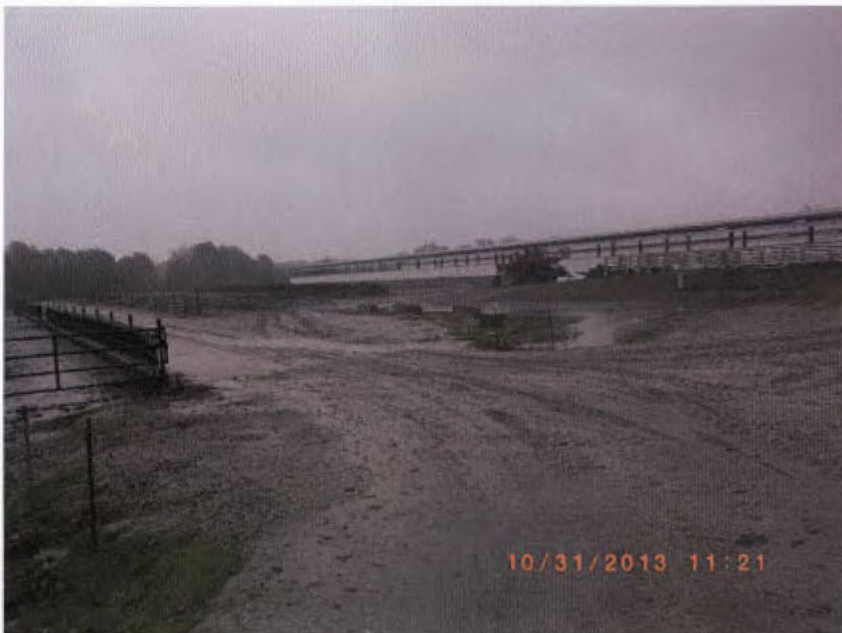
61: IMGP0583

Description: Runoff from composting area flowing to ditch along east side of central access road.

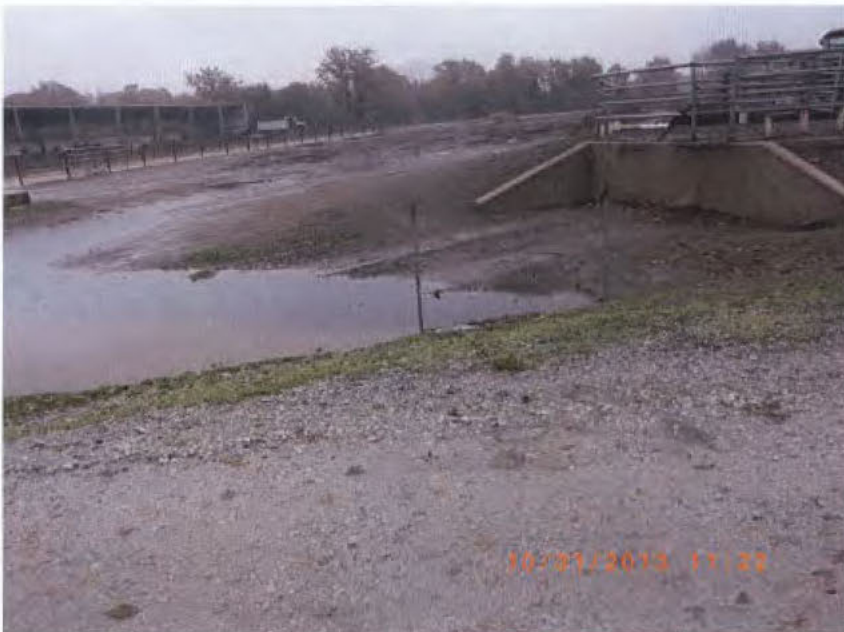
65: IMGP0587

Description: Flow of runoff from pen area and composting area flowing into pipes under access road south of composting area.

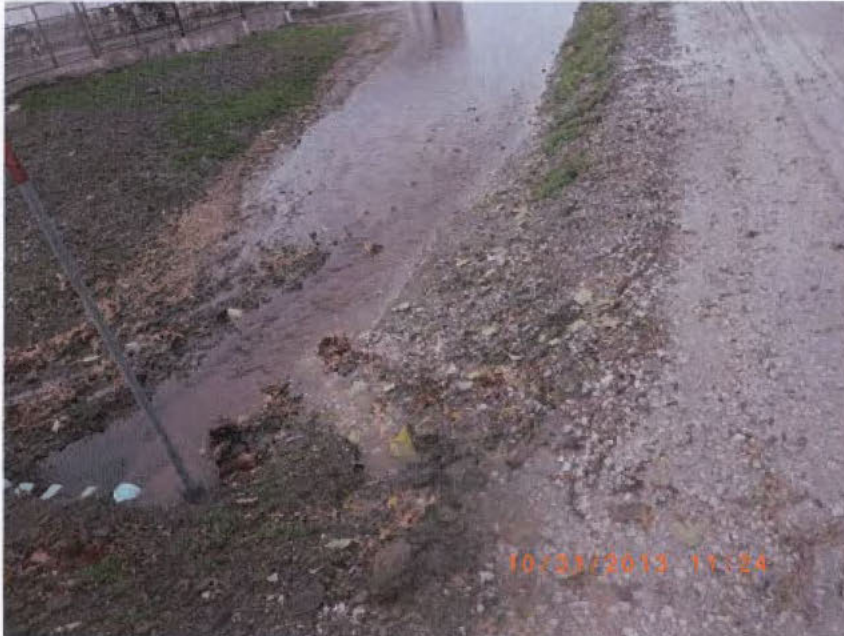
66: IMGP0588

Description: Outlet of pipes conveying runoff from pen area and composting area under road south of composting area on east side of central access road.

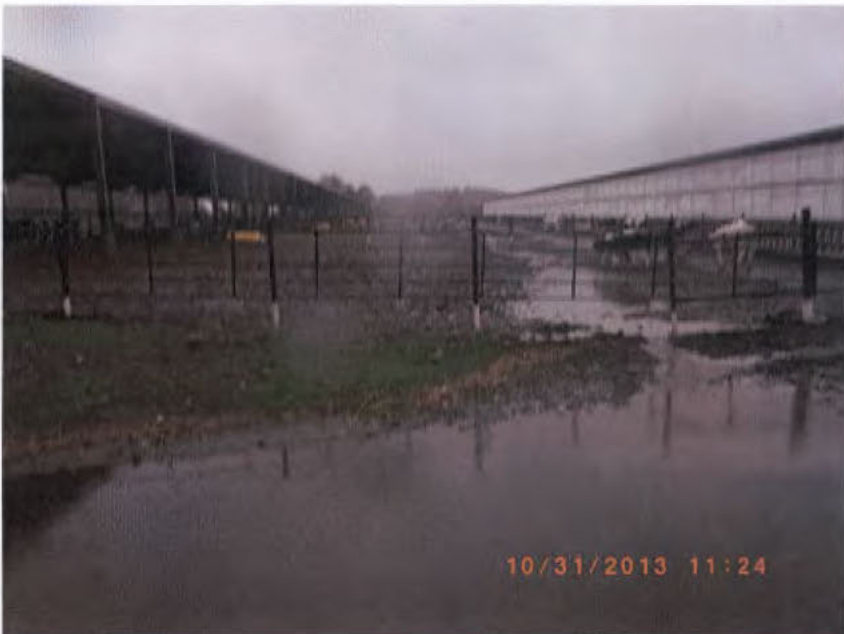
67: IMGP0589

Description: Runoff from pen 5 flowing to ditch on east side of central access road.

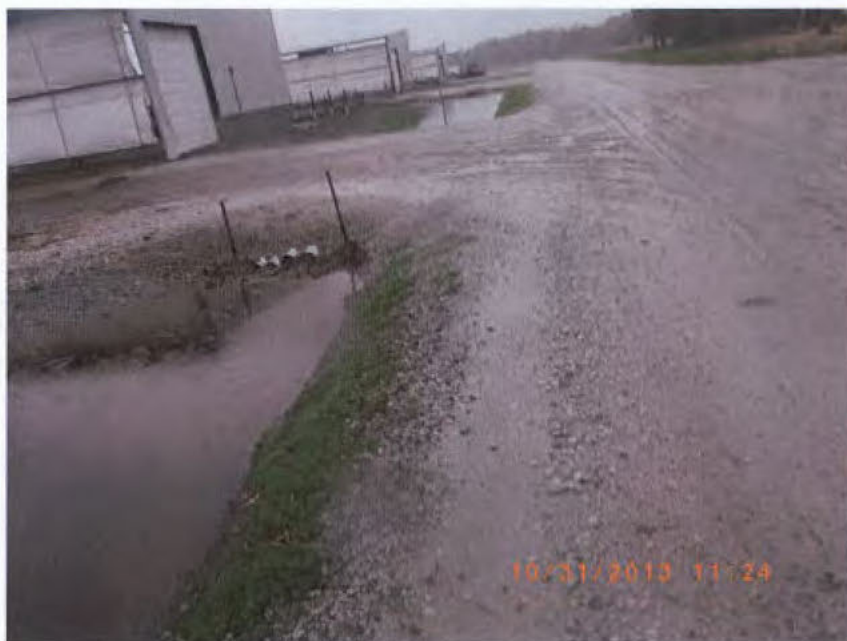
68: IMG0590

Description: Pipes under road between pen 5 and pen 4 conveying flow south in ditch on east side of central access road.

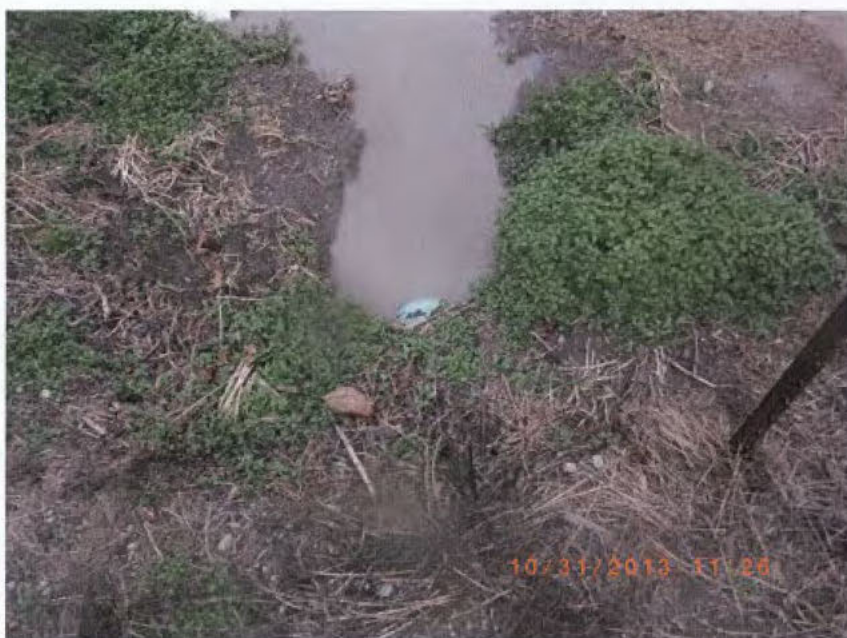
69: IMG0591

Description: Green pipe under central access road flowing into grassed swale on west side of central access road.

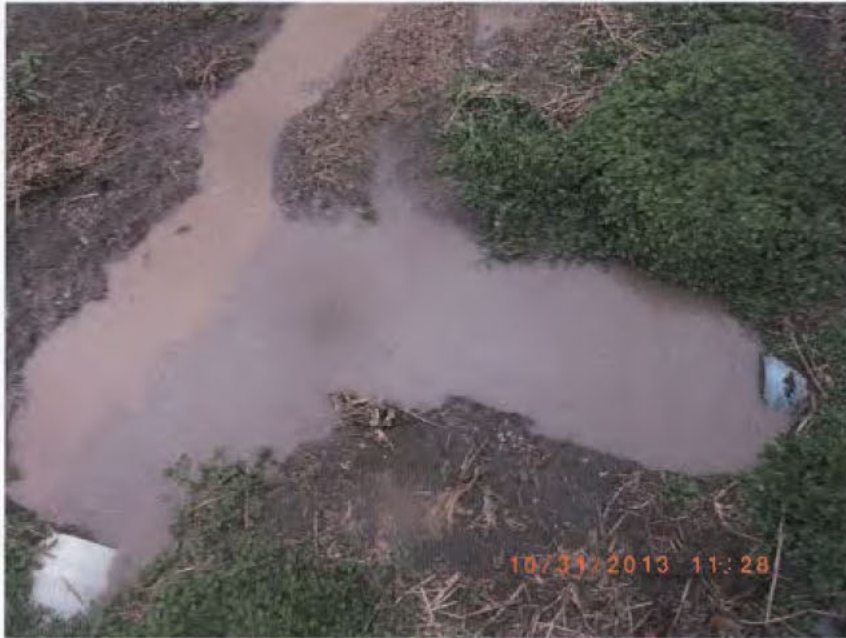
70: IMGP0592

Description: Flow from green pipe under central access road (photo 69) and flow in grassed swale converging and flowing south into white pipe under east-west road between calf hutch area and pen area.
